Manhole Inspection Summary

Manhole # S19AA_028MH

Location Address: **2000 PAYSON ST**

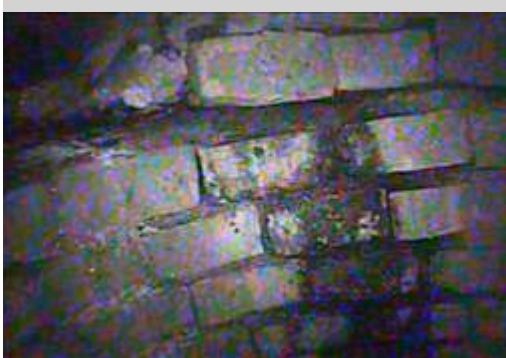
Defect 3

Infiltration: ☐ None ☒ **Joint** ☐ Cracks ☐ Mortar ☐ Roots ☐ Wall

BARREL INFILTRATION

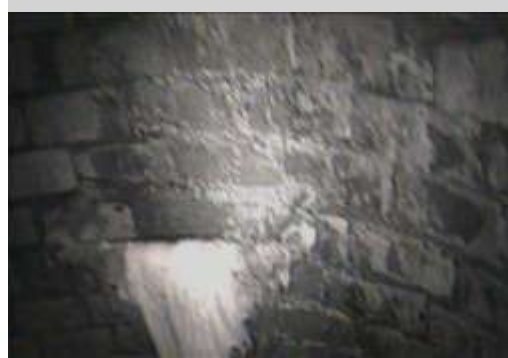
Defect 2

☒ **Evidence Of Surcharge**

Depth: **6** (ft.) ☐ Active Surcharge Present

SURCHARGE EVIDENCE

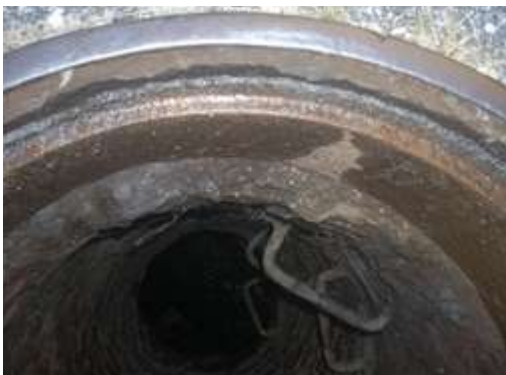
Defect 1

Offset: **1** (in.)

FRAME OFFSET

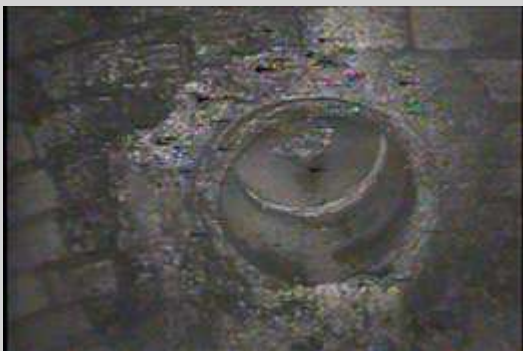
3 O'Clock Inflow

BARREL INFILTRATION

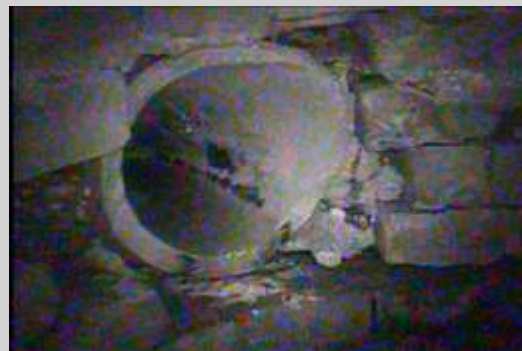
Drop In @ 3 O'Clock

BARREL INFILTRATION

Drop: **Outside** Rod and Bar
Angled: **Yes** Reading: **12.80** (ft.)
Inv Depth: **13.80** (ft.)
Drop Condition: **Open**

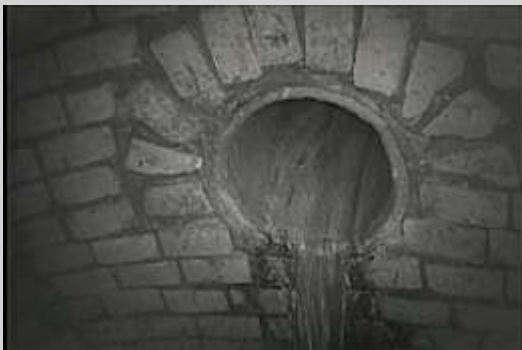
9 O'Clock Inflow

BARREL INFILTRATION

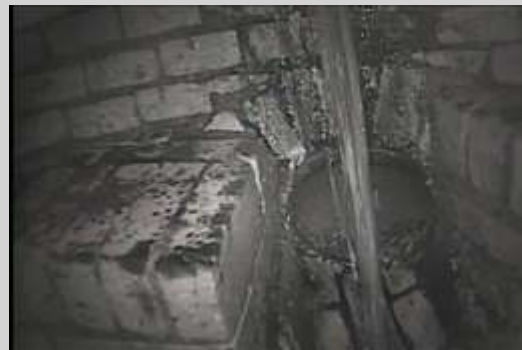
Drop In @ 9 O'Clock

BARREL INFILTRATION

Drop Condition: **Clogged**
